**HYDROLOGICAL STUDY
OF THE 859 ACRE
LIMONAR DEVELOPEMENT / WONDERLY HOLDINGS
PARCEL PROPOSED FOR INCLUSION IN THE
MIAMI-DADE COUNTY URBAN DEVELOPMENT BOUNDARY
SECTIONS 30 & 31, TOWNSHIP 54 SOUTH, RANGE 39 EAST
MIAMI-DADE FLORIDA**

**CRB GEOLOGICAL & ENVIRONMENTAL SERVICES, INC.
8744 S.W. 133RD STREET
MIAMI, FLORIDA 33176
(305) 447-9777**

JUNE 25, 2014

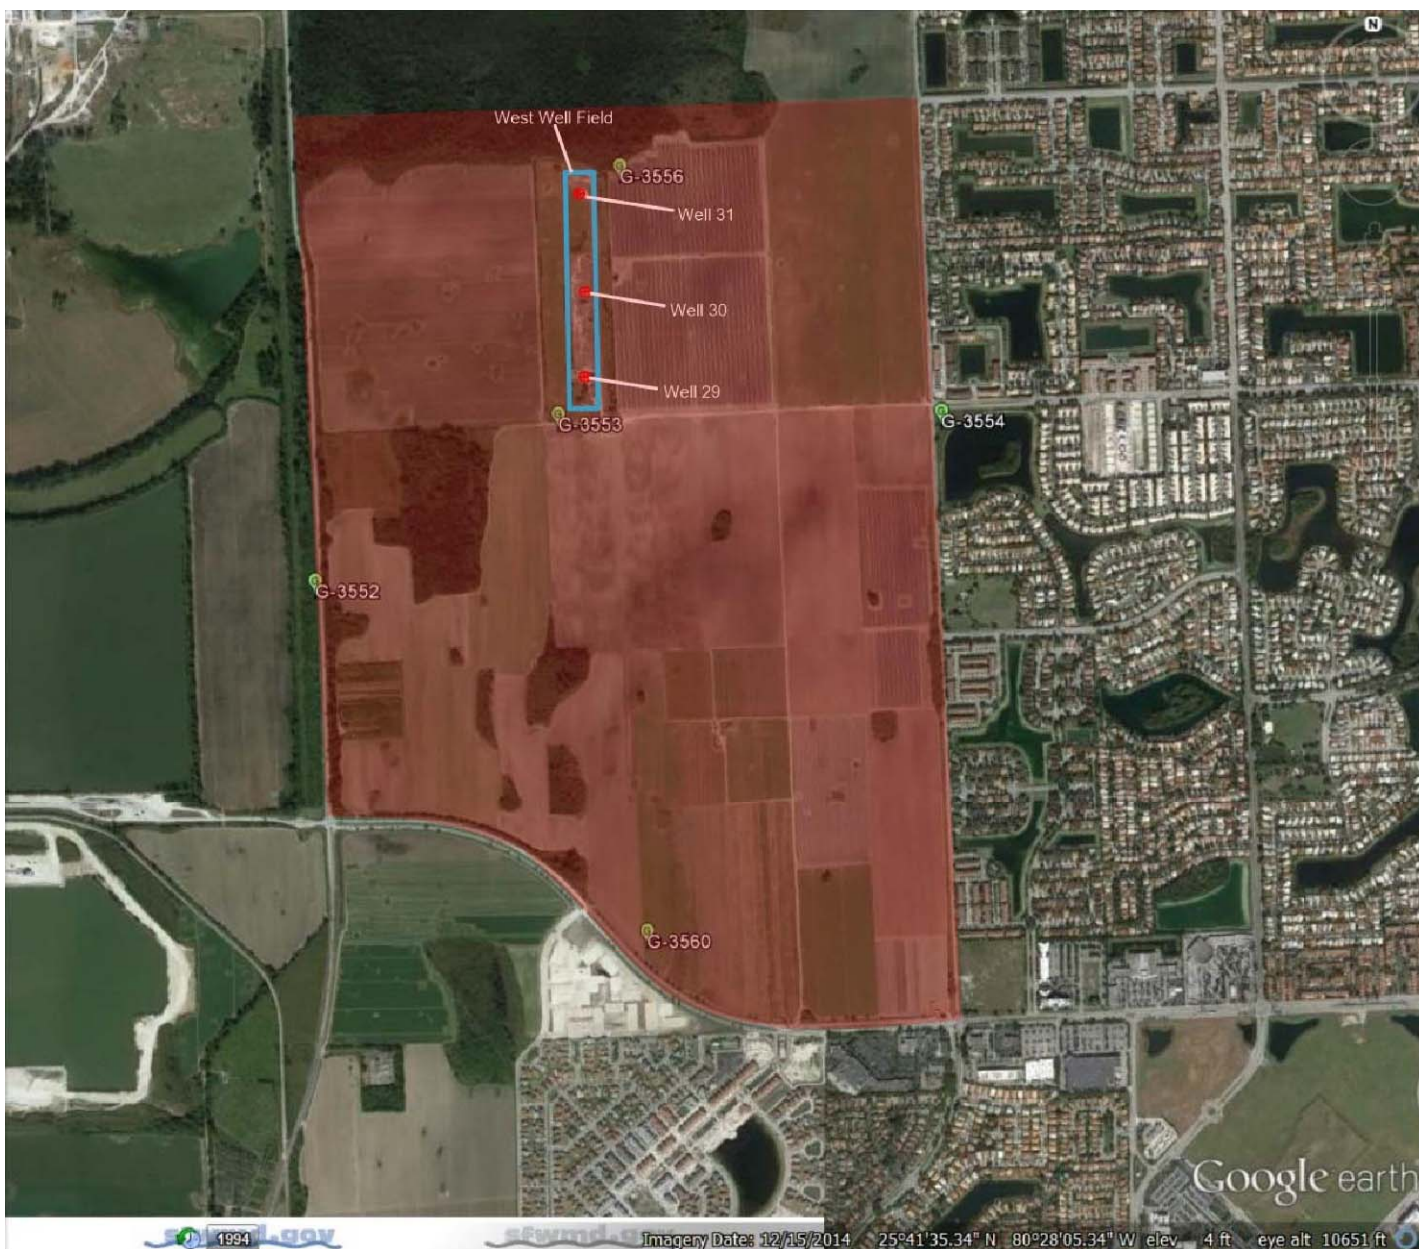
FIGURE
2

SITE MAP SHOWING LOCATIONS OF SELECT USGS MONITORING WELLS (G-3552, G-3553, G3554, G-3556 & G-3560) AND PRODUCTION WELLS (WELL 29, 30 AND 31) AT WEST WELLFIELD.

The USGS maintains a nationwide network of groundwater monitoring stations. There are several USGS groundwater monitoring wells located within the boundaries of the Site that were used in this study. Data available from these stations consist of periodic measurements of groundwater elevations (hourly, daily) relative to 29 NGVD, generally over the last 20 years or so. In that regard these data are well suited to document long-term hydrologic changes at the Site. USGS wells used for this study are identified as G-3552, G3553, G-3554, G-3556, and G-3560. Their locations are shown in Figure 2.

The WWF started operation (groundwater extraction) in 1994. Extraction of groundwater occurs via three extraction wells (W-29, W-30, W-31). Their locations are shown in Figure 2. The combined design rated capacity for the WWF is 16 million gallons per day (MGD). Production data were obtained from the Miami-Dade Water and Sewer Department (MDWSD) several years ago and span the period between January 1994 and February 2011. Attempts were made to obtain more recent data (i.e. 2011 through the present day), however, for some reason requests were not honored by the MDWSD citing security reasons and non-availability of data in electronic digital format.

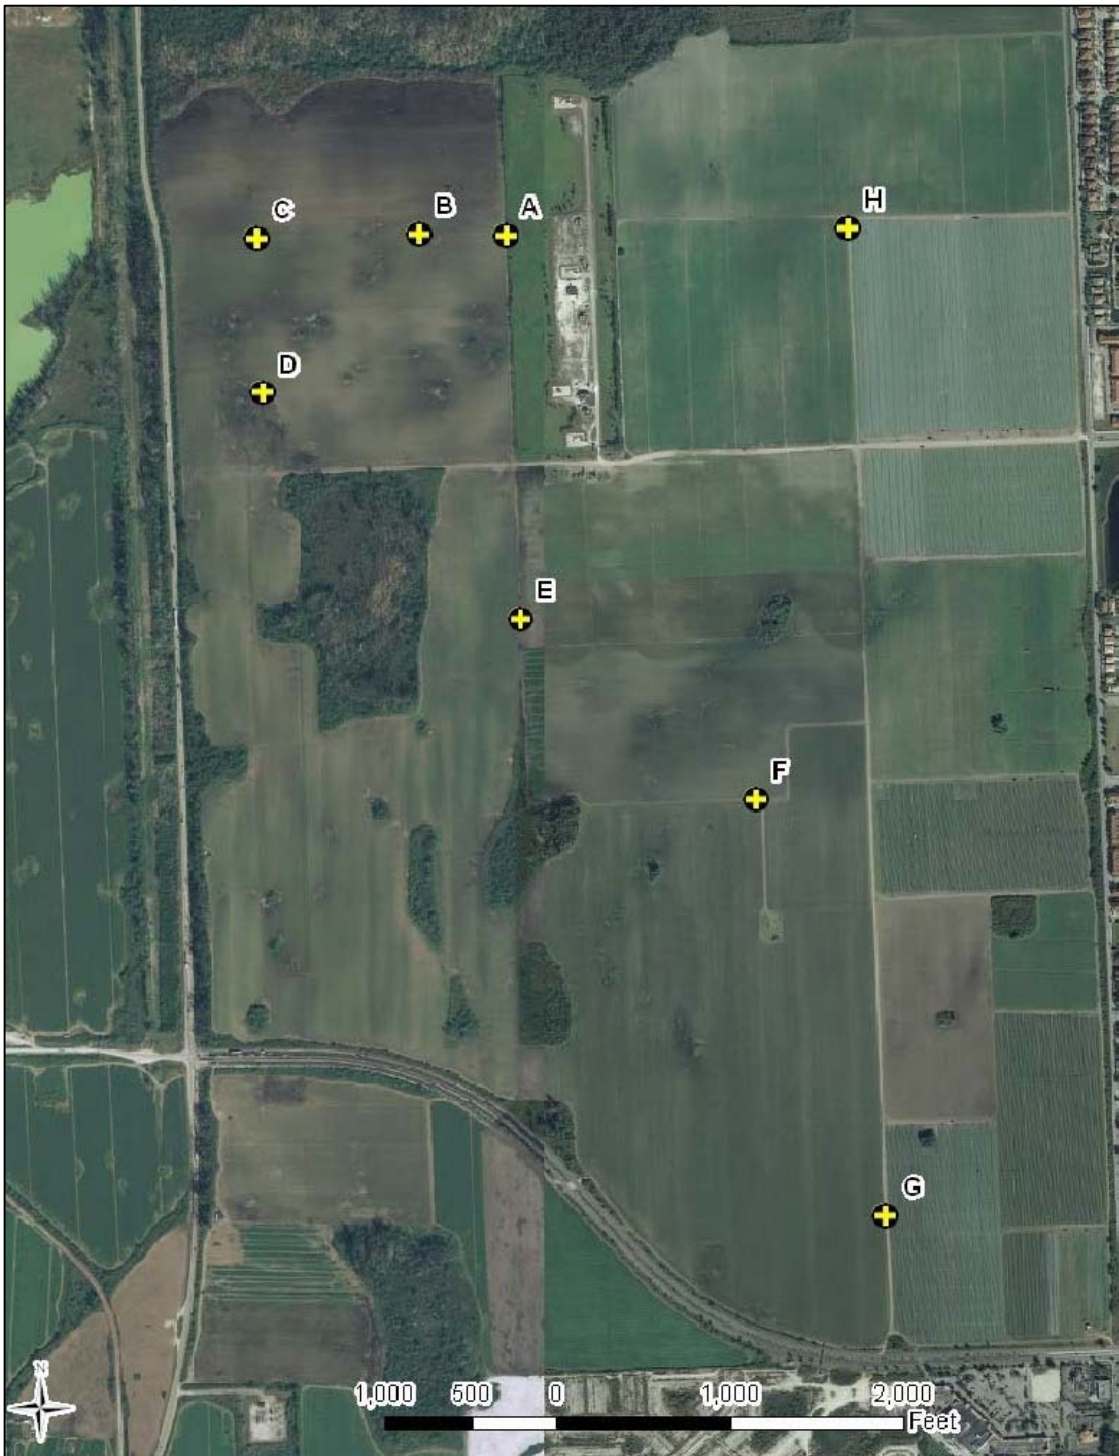
AERIAL VIEW OF SITE SHOWING LOCATION OF GROUNDWATER PIEZOMETERS INSTALLED AND MONITORED BY CRB

CRB installed piezometers A through H at various locations (Figure 5) to monitor groundwater elevations at the Site and document any potential effects of the West Well field on groundwater elevations at the Site. Dedicated data loggers were installed in all piezometers with one data logger dedicated to monitor barometric pressure for compensation purposes during data analysis. Data from these piezometers span from 2011 through 2014.

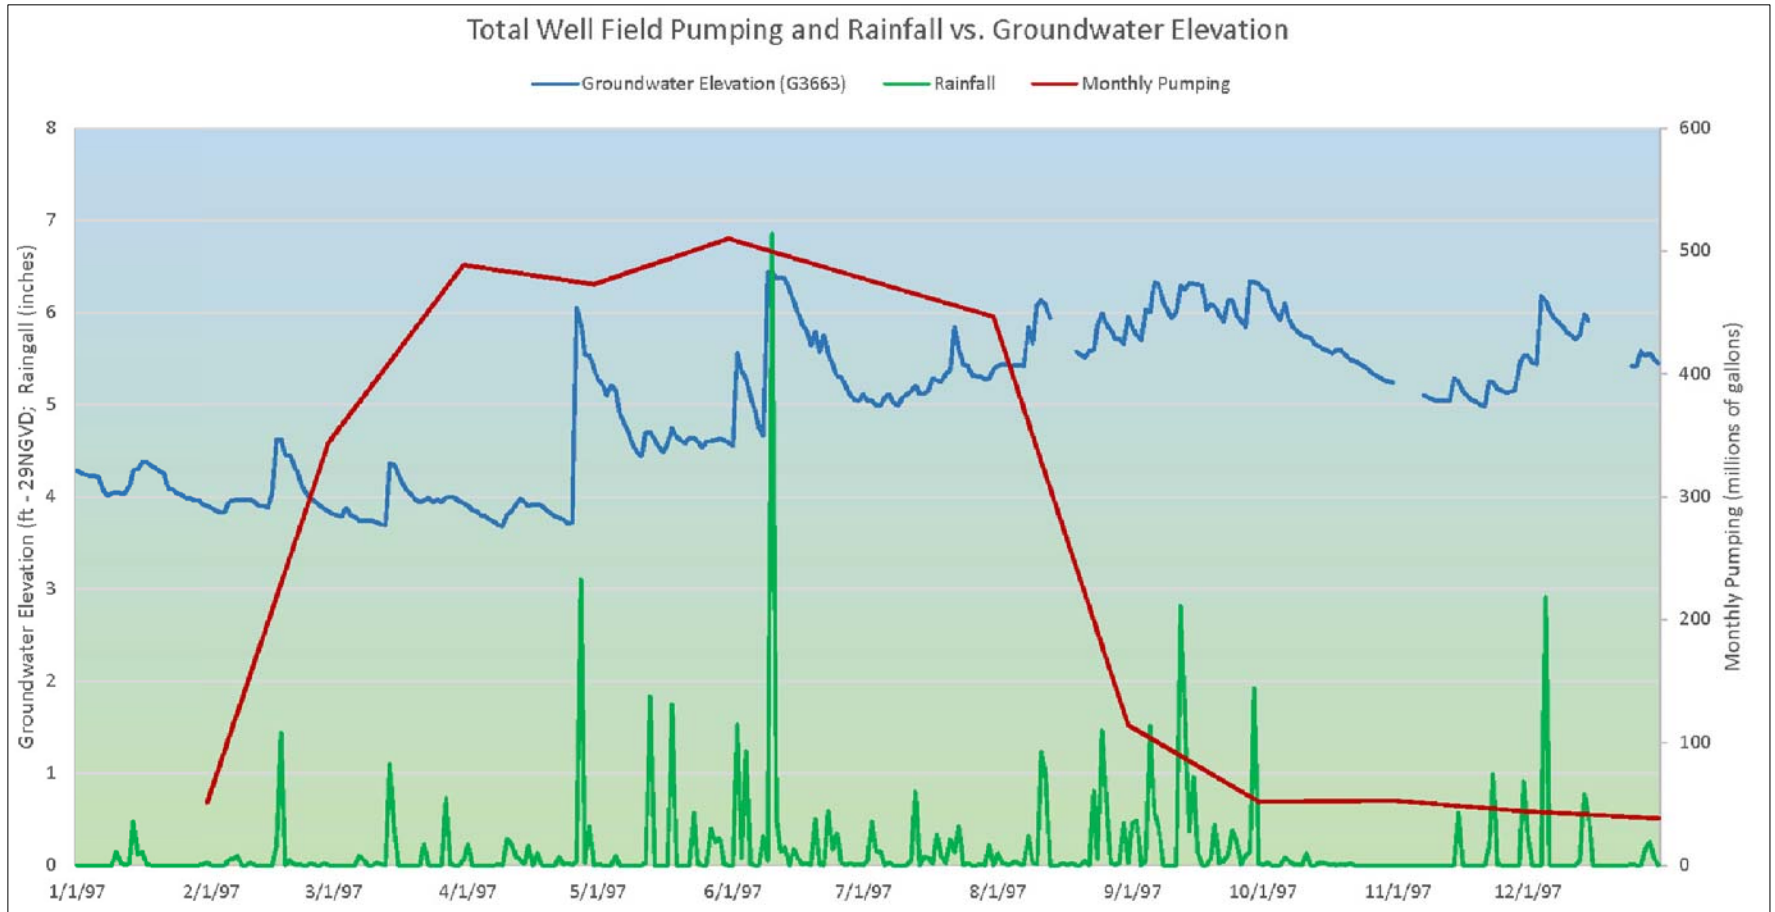
FIGURE
8

GROUNDWATER ELEVATION RESPONSE TO PRECIPITATION AND WEST WELL FIELD PUMPING. PRECIPITATION CAN BE SEEN TO BE THE DOMINANT FACTOR IN PRODUCING GROUNDWATER FLUCTUATIONS IN THE SHORT-TERM AND CAN MASK EFFECTS OF GROUNDWATER WITHDRAWAL ASSOCIATED WITH PUMPING ACTIVITIES.

Groundwater in south Florida is relatively flat with a mild easterly to southeasterly regional gradient. The groundwater gradient at the Site generally follows the regional gradient with higher groundwater elevations to the west, supported / recharged by the L-31N canal. The groundwater gradient is periodically masked by overprints of localized precipitation events and groundwater withdrawal associated with West Well Field. Figure 7 shows pumping rates at WWF to have been ranging from about 300 to 500 million gallons per month or approximately 10 to 16 million gallons per day (MGD). Precipitation by far exerts the most dominant influence on short term groundwater fluctuations and can completely mask the effects of groundwater withdrawal associated with the well field as shown in Figure 8. As can be seen in this figure, an increase in water production from below 100 MGM to 500 MGM within the time period of February 1997 to April 1997 had no apparent effect on groundwater elevations recorded in G-3553. Precipitation, events on the other hand, are directly linked to marked groundwater fluctuation and can be seen to directly cause a significant groundwater level rise while pumping is at its peak (May 1997 to August 1997).

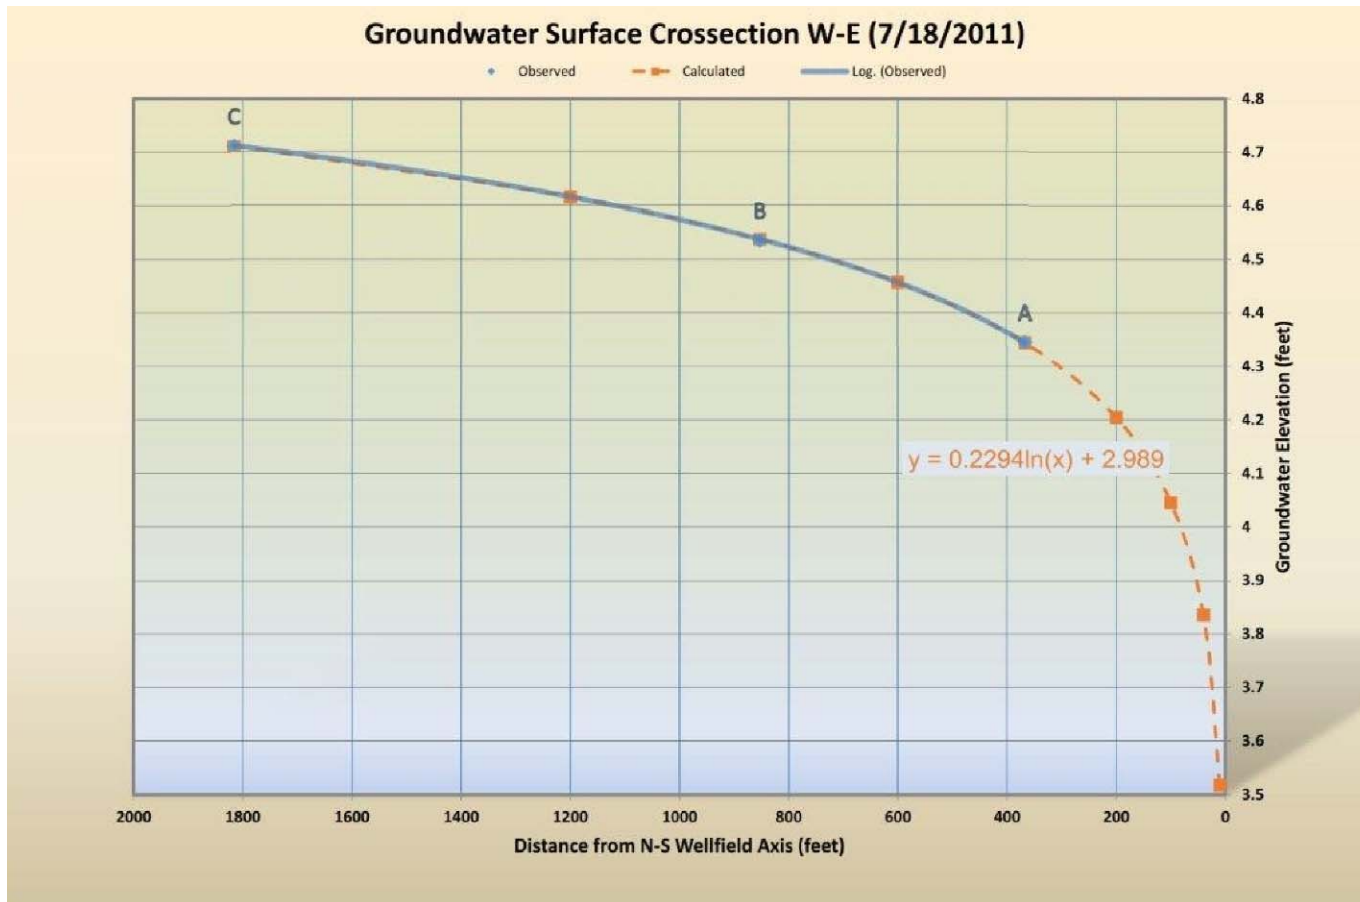
FIGURE
 9

PARTIAL CONE OF DEPRESSION RECORDED FROM CRB PIEZOMETERS C, B, AND A SHOWN IN BLUE. EXTENDED CONE OF DEPRESSION OUTLINE WAS CALCULATED BY FITTING A LOGARITHMIC FUNCTION (SHOWN IN RED) TO THE OBSERVED DATA.

Data collected by CRB through a network of piezometers shows the well field to have a relatively subtle influence on groundwater levels. Cross sections of groundwater elevations from west to east, show the effect of water withdrawal from three production wells on water levels as the presence of a shallow cone of depression which is partially depicted in Figure 9. This shallow configuration of the cone of depression is consistent with very high hydraulic conductivities at the Site of approximately 20,000 ft/day (Figure 10) (Brakefield *et. al.*, 2013). From the piezometers C, B, A, and H, along a west-east transect, the cone of depression in the upgradient as well as downgradient directions associated with the West Well Field water extraction was estimated and is shown in Figure 11. The greatest groundwater depression associated with the West Well Field can be expected east of the well field center line i.e. in the downgradient direction and was estimated at approximately one-half (0.5) feet at a distance of approximately 500 feet from the well field. The drawdown observed in CRB piezometers and resulting from well field pumping appears to be somewhat less than previously modeled results.

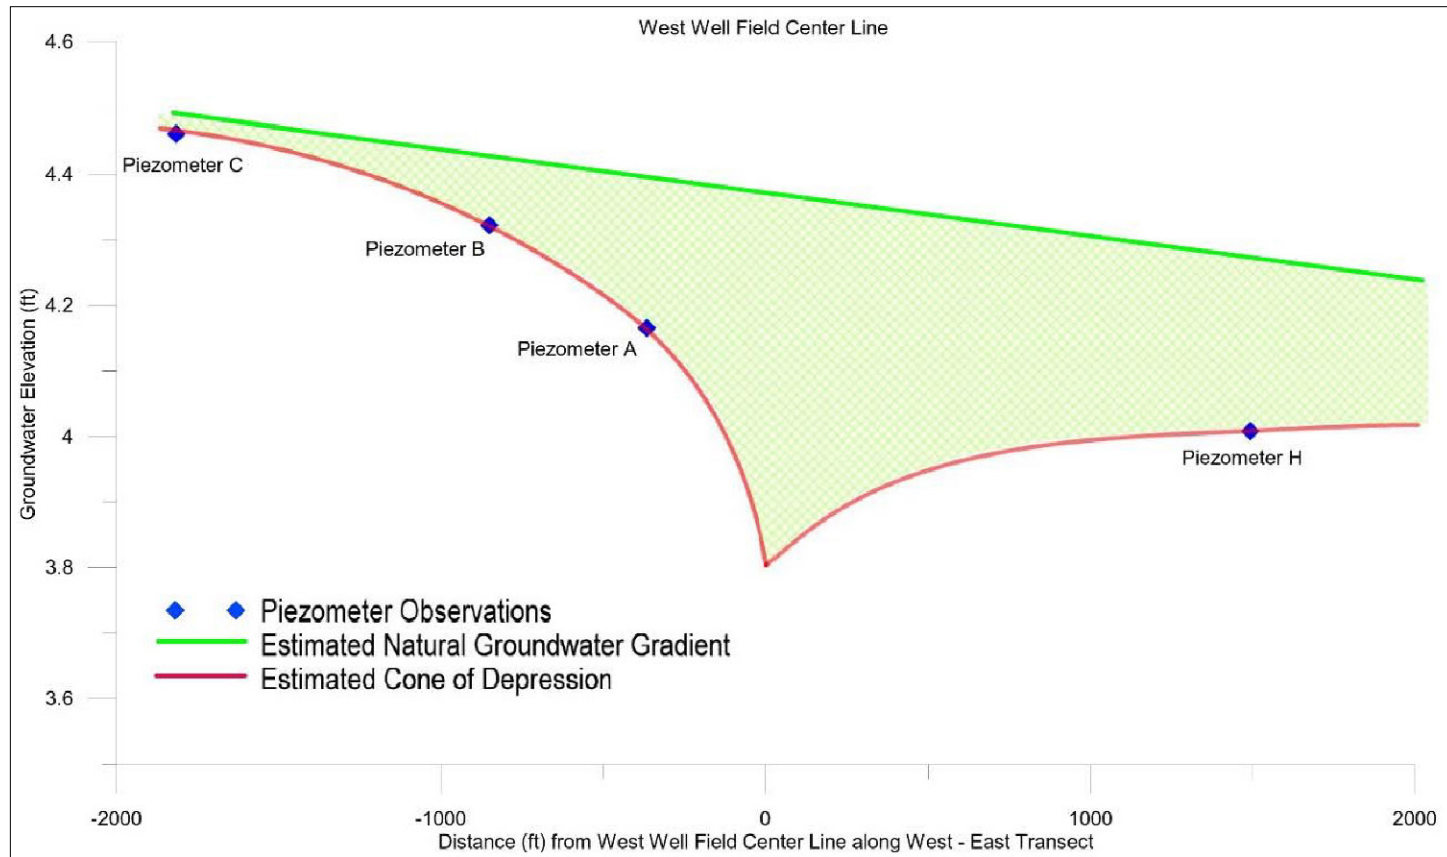
FIGURE
11

PIEZOMETER OBSERVATIONS AT PIEZOMETERS C, B, A, AND H ALONG WEST-EAST TRANSECT ACROSS WEST WELL FIELD CENTER LINE. CONE OF DEPRESSION ASSOCIATED WITH WELL FIELD PUMPING IS ESTIMATED BASED ON PIEZOMETER READINGS AND IS SHOWN IN RED. GREEN LINE INDICATES ESTIMATED POSITION OF GROUNDWATER WITHOUT THE INFLUENCE OF PUMPING.

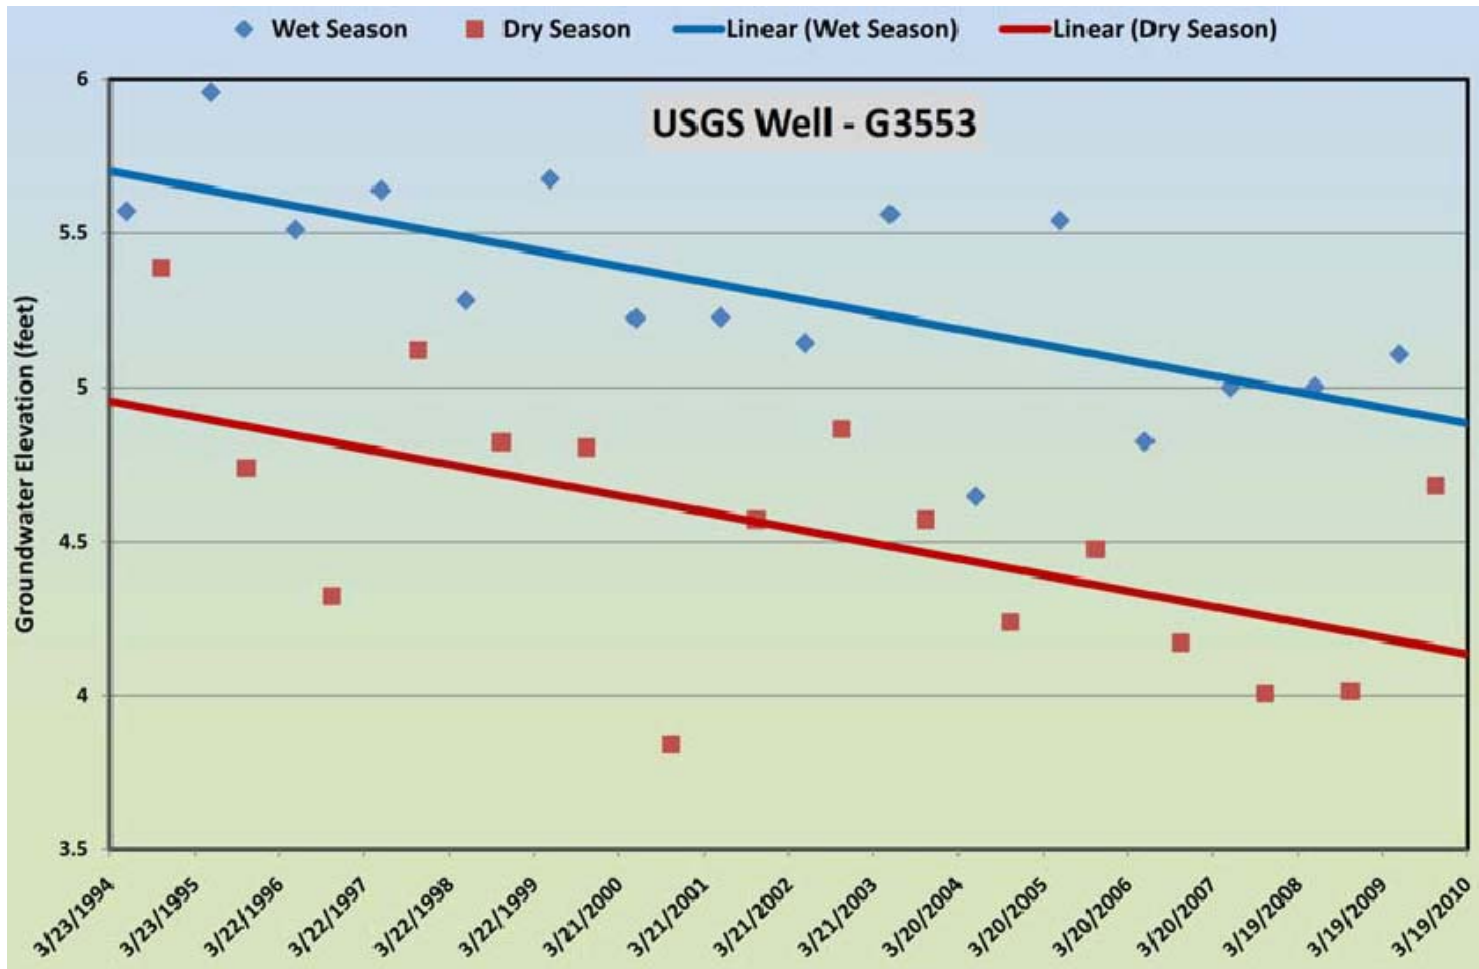
COMPARISON OF WET SEASON AND DRY SEASON GROUNDWATER LEVEL DECLINE OVER THE LAST TWO DECADES.

When comparing groundwater elevations within the monitoring period during dry and wet seasons, one finds very similar trends. Figure 16 depicts average groundwater elevations during wet and dry seasons and shows the rates of decline to be almost identical.

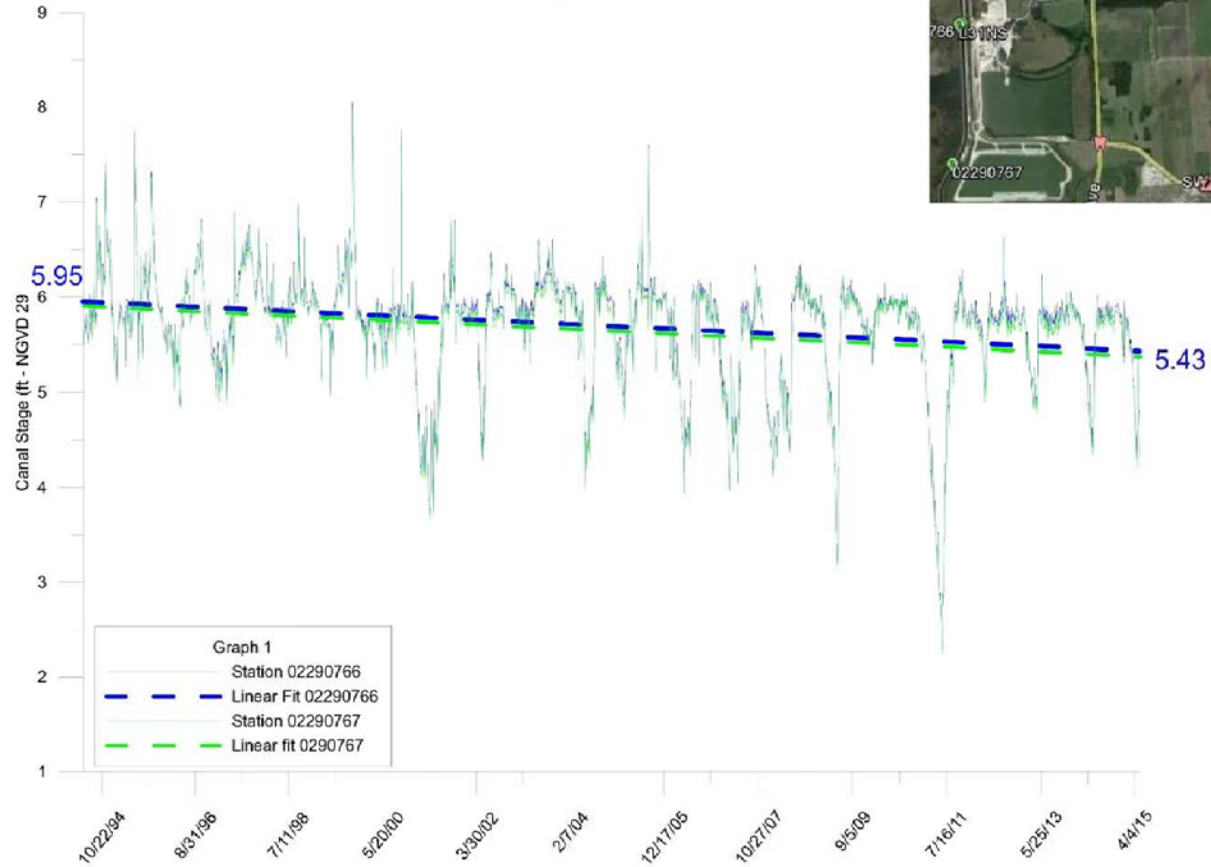
FIGURE
17

CANAL STAGES FOR L-31N STATIONS 02290766 AND 02290767

Water elevation data in drainage canals maintained by the SFWMD are available for similar time periods as groundwater data in wells maintained by the USGS. Regional groundwater elevations are controlled to a predominant degree by maintaining drainage canal stages in the area through the operation of control structures that either allow water to pass and be discharged further downstream, thus lowering groundwater tables, or hold water back to raise groundwater levels. Groundwater levels at the Site and surrounding areas are subject to canal stages maintained by the SFWMD in the Tamiami Canal that runs west to east, north of the Site and the L-31N canal that runs north to south, west of the site. As the Tamiami canal is further from the site, data from two canal gauge stations along L-31N (02290766 and 02290767) were chosen for evaluation in order to gain a better understanding of long-term groundwater trends exhibited at the Site. Figure 17 shows hydrographs for L-31N stations 02290766 and 02290767, approximately one mile west of the Site. Short-term fluctuation in water elevation recorded at these two station are primarily related to precipitation in and around the area of the stations and are similar in character to fluctuations observed in hydrographs from monitoring wells. Evaluation of the long-term water elevation in L-31N canal reveals a lowering of canal stage of over 0.5 feet over the last 20 years.

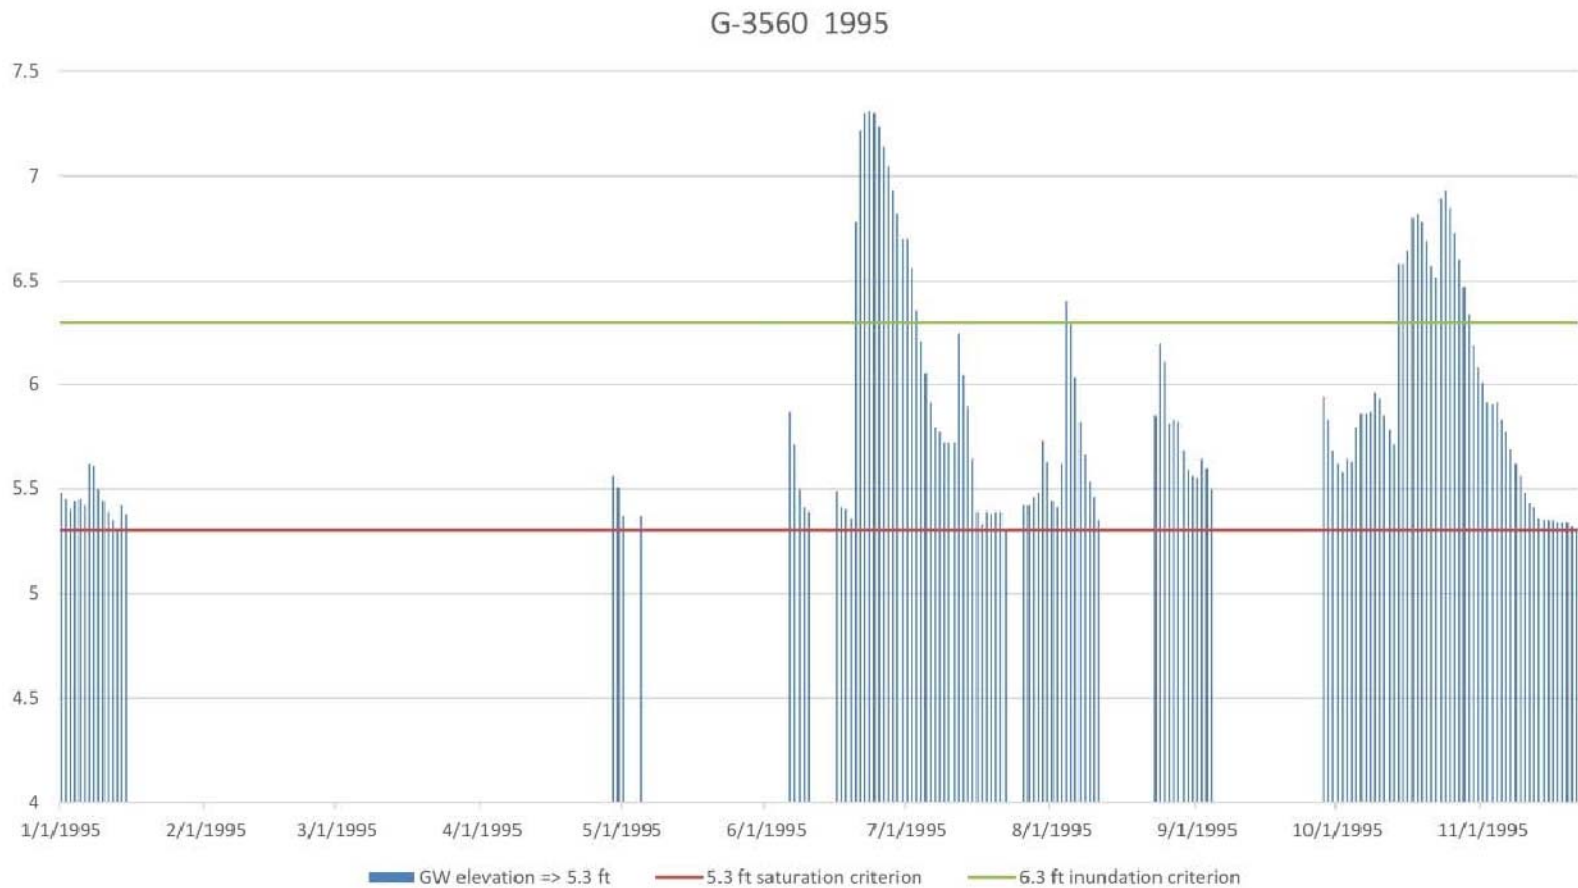
FIGURE
20

WETLAND HYDROLOGY CRITERIA MET IN 1995 AS DETERMINED BY GROUNDWATER ELEVATIONS IN G-3560 EXCEEDING CONSECUTIVE 20 DAYS OF SATURATION (MOST CONSECUTIVE CASE OF WITHIN 1 FT. OF SURFACE I.E. BETWEEN 5.3 AND 6.3 FT. AND 7 CONSECUTIVE DAYS OF INUNDATION I.E. 6.3 FT. OR HIGHER).

Groundwater levels from years 1995 through 1999, representing the earliest five years of available groundwater elevation data were compared to years 2010 through 2014, representing the most recent five years of data. Daily maximum groundwater elevations within the period of each year were searched for conditions during which saturation and inundation occurred. The frequency and chronology of these occurrences during each of the studied years are represented in Figures 20 through 24 (1995 through 1999) and Figures 25 through 29 (2010 through 2014). Only days that exceeded the saturation criterion are shown in these figures.

During the time period 1995 through 1999 saturation occurred during 582 days compared to 160 days during 2010 through 2014. Inundation occurred during 57 days during the earlier period as compared to 4 days during the later period. Furthermore, hydrology consistent with the presence of wetlands or wetland function was documented by a condition of inundation lasting at least seven consecutive days or saturation lasting at least twenty consecutive days during four out of the five years during the time period 1995 through 1999 (Figures 20, 21, 22, and 24). Conversely, during the period 2010 through 2014 hydrology consistent with the presence of wetlands or wetland function never occurred. This profound difference in hydrology at the Site

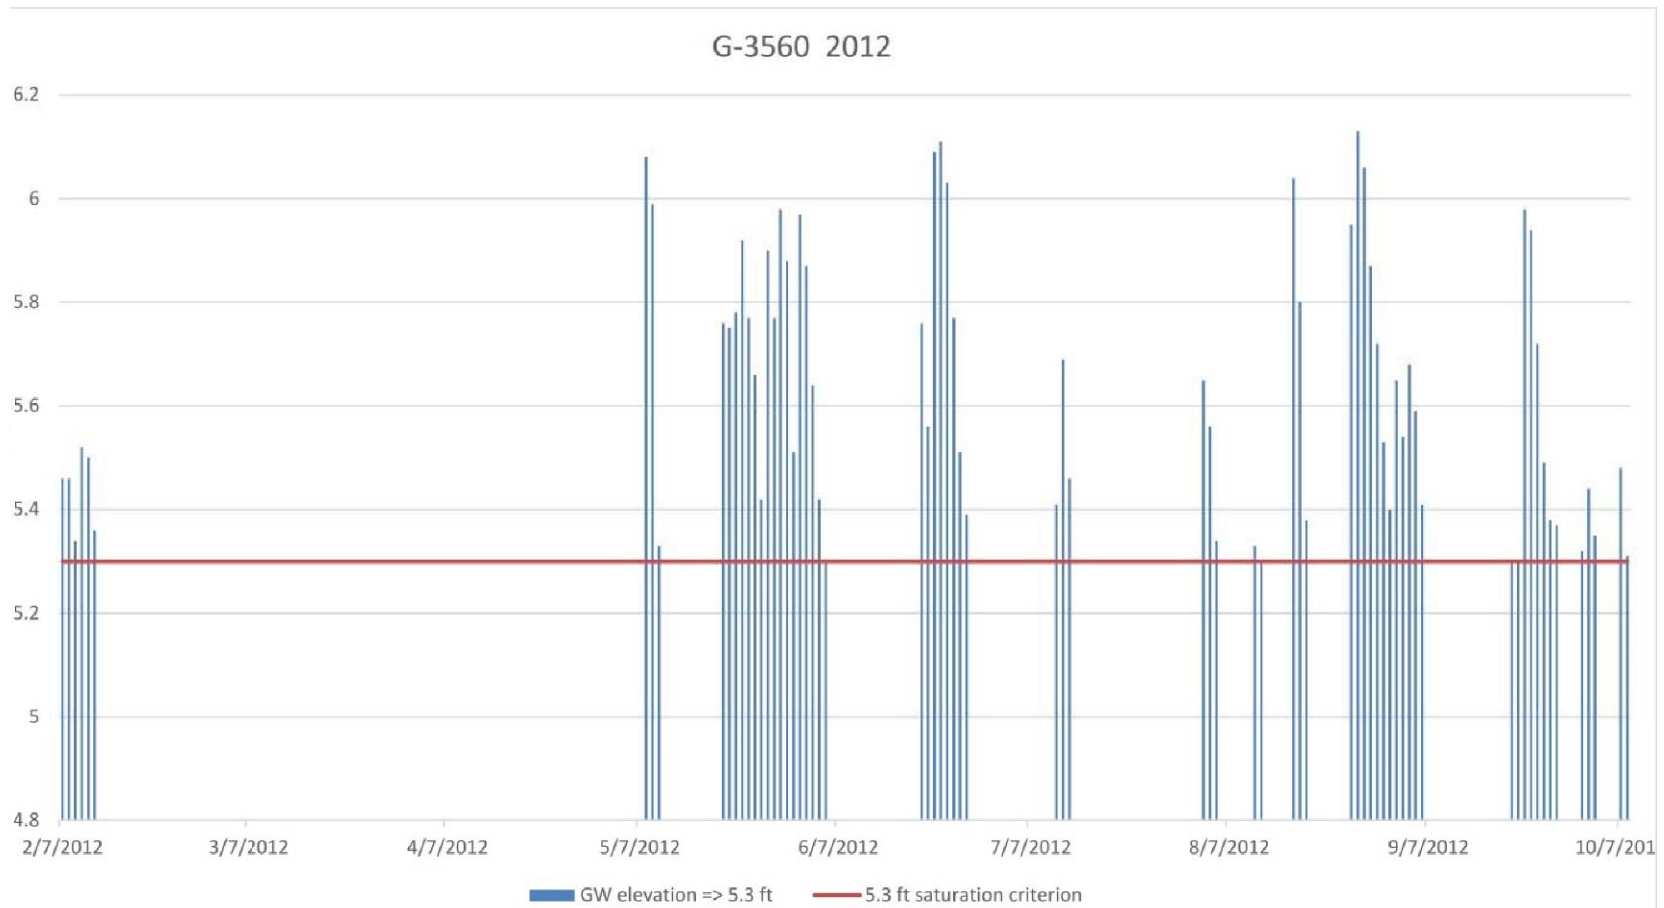
FIGURE
27

WETLAND HYDROLOGY CRITERIA ARE NOT MET IN 2012 AS DETERMINED BY GROUNDWATER ELEVATIONS IN G-3560 NOT EXCEEDING 20 CONSECUTIVE DAYS OF SATURATION (MOST CONSECUTIVE CASE OF WITHIN 1 FT. OF GROUND SURFACE; I.E. BETWEEN 5.3 AND 6.3 FT.)
